**Ludlow United Church
48 Pleasant Street
Ludlow, VT**

**Capital Needs Assessment
August 25, 2014**

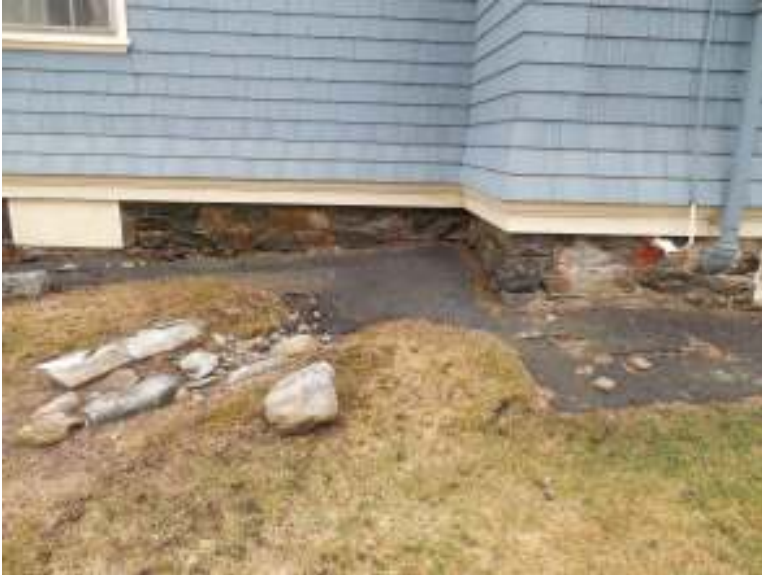
Drainage has been a problem at the back of the site. There are lawns around the building and some trees at the back of the site.

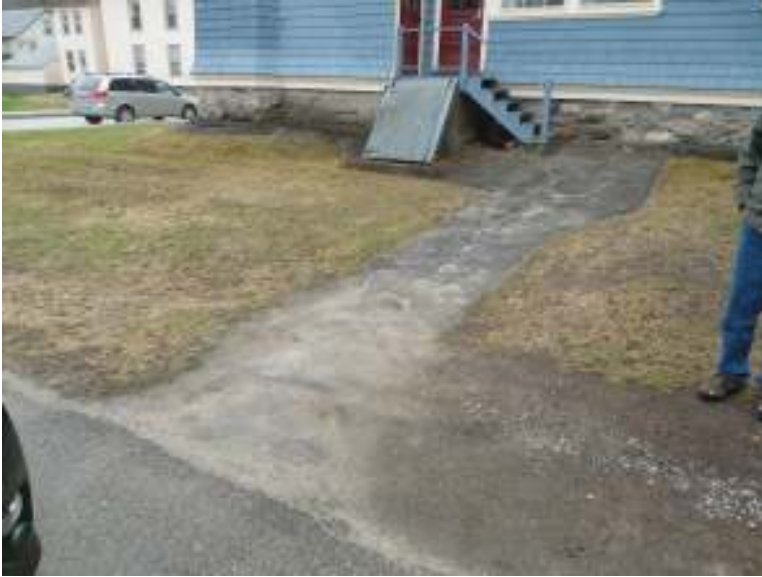
The site slopes away from the building at the front but the drainage at the back of the site is problematic. There are issues around the base of the building where roof run off is not getting away from the foundation wall effectively and in the yard areas where water is pooling.

There is asphalt at the perimeter of the building in an effort to prevent water from going into the ground near the foundation. The paving has decayed and it should be replaced. It should have a better drainage system installed around the base of the building that includes repairs to the foundation wall mortar, footing drains, better draining back fill and drainage stone at the surface. The existing

Drainage improvements are budgeted in year 1 to prevent further water damage to the basement.

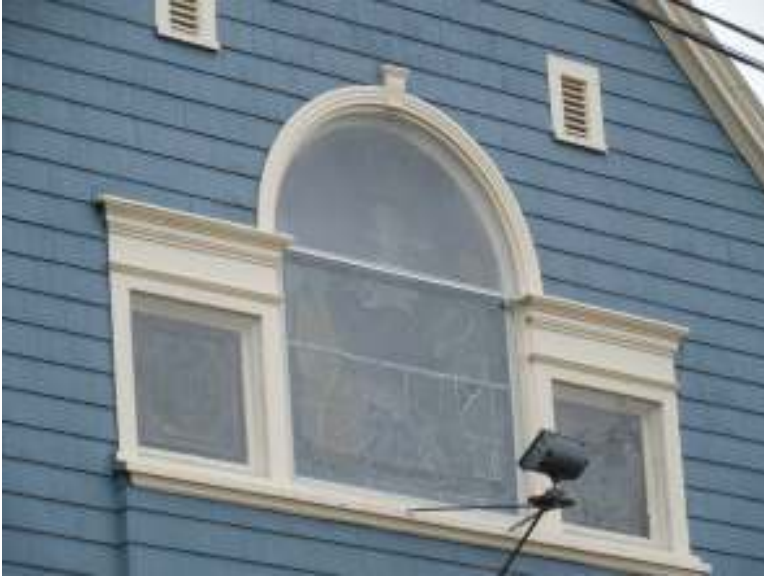
The building has a mixture of wood window types. The windows outside the sanctuary are wood double hung windows with aluminum triple track storm windows. There are exceptions on the second floor that lack storm windows. The sanctuary has fixed stained glass windows with exterior storm panels, again one window appear to lack a storm panel.

The double hung wood windows are probably original to the building. They appear sound and those with storm windows have been protected from most damage. The glazing compound and frames inside the storms do not appear to have been repaired or painted in the recent repairs. This is a cost and labor savings that works for a while if the storms are kept closed consistently. There is

some putty damage that should be repaired before water works into the adjacent wood. This could be done as maintenance if there is a skilled painter available.

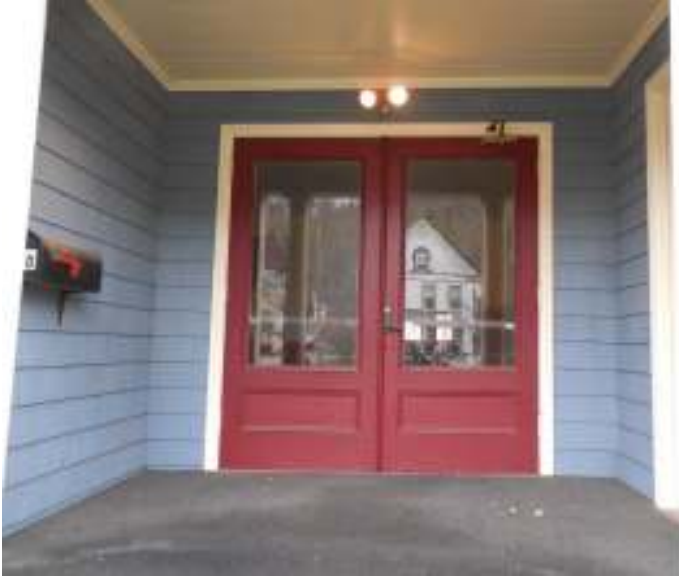
The building has double front doors, a door to the side office and rear doors to the back stairway and meeting hall.

The front double doors are wood with glass and likely to be from 1892. They are an important part of the historic appearance of the building and should be preserved. A round of repairs is budgeted in year 12.

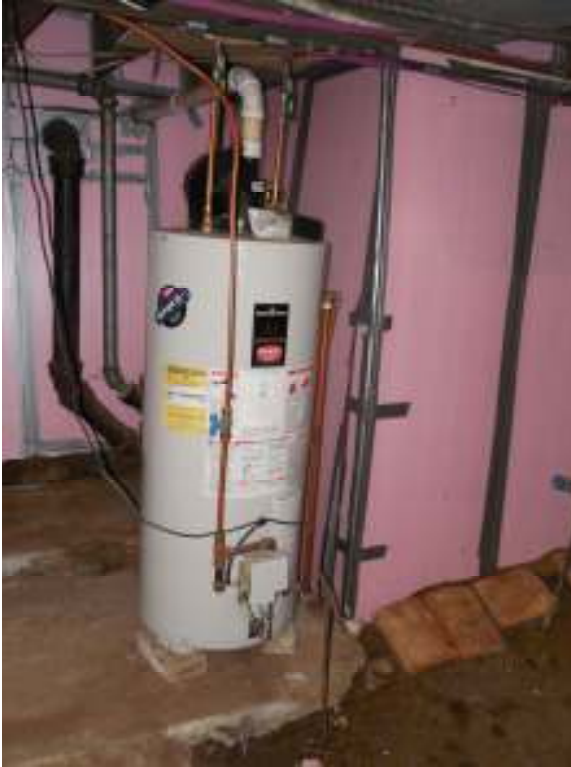
The hot water is provided by a propane fired Bradford White hot water heater. It appears to be about 10 years old. No problems were reported. It is budgeted for replacement in year 6.

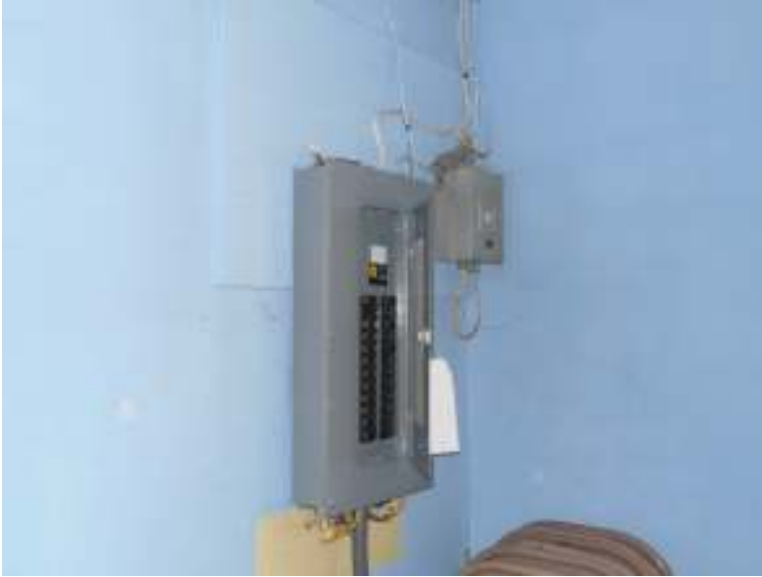
The building electrical system has been maintained over the years and appears mostly adequate. There is a recent vintage breaker panel in the storage area off the kitchen and an older breaker panel in the upstairs meeting room.

There are concerns. The older light fixtures, particularly the hanging fixtures on the second floor

have their original wiring. This is cloth covered, beyond the end of its useful life and potentially dangerous. These fixtures should be rewired. The existing bulbs should be replaced with LED bulbs during the repairs.

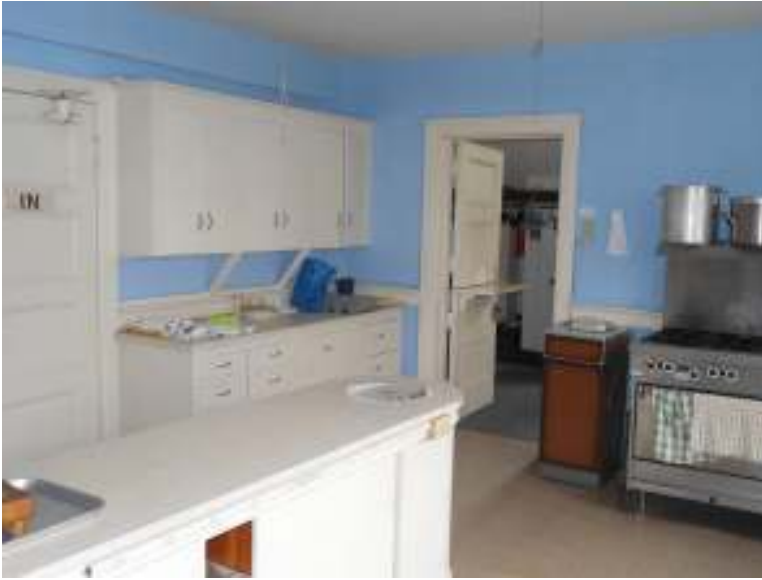
The kitchen has cabinets and counters from the 1950's or thereabouts. They appear functional and no problems were reported. The kitchen receives moderate use and meals are prepared there on a regular basis, but less than weekly. There are two double sinks, a ten burner stove with two ovens and refrigerators. It has a vinyl composition tile floor.

The installation of the range is probably a code violation. It lacks a commercial grade exhaust hood. My understanding is these large commercial ranges require them. You should investigate and meet this requirement in year 1.

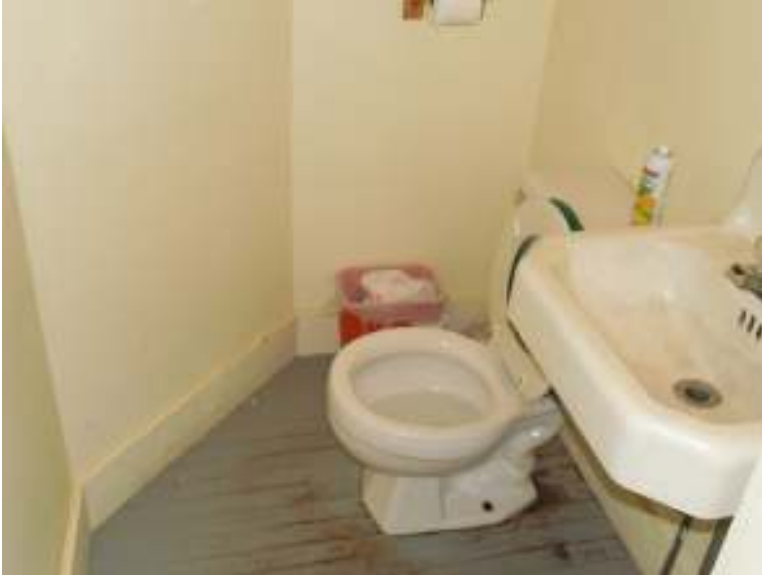
There are two older bathrooms. Neither is accessible to the handicapped. This is a significant issue to a facility that wishes to serve members of all abilities and health. You should plan and implement an accessible bath project in year 1.

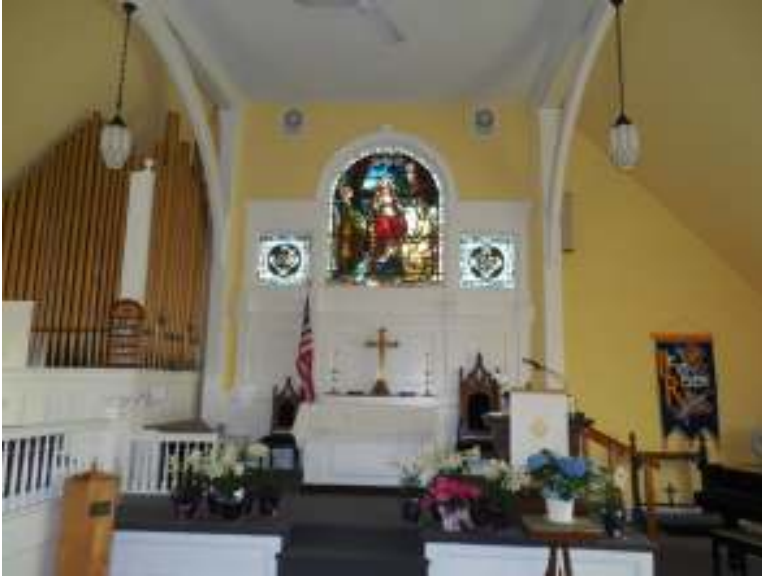
The interior includes an office, several meeting rooms, hallways, stairways and the sanctuary worship space. The interiors vary wildly in condition. The sanctuary is one of the more attractive places of worship I have visited. At the other extreme, the play room is badly worn and has damage to the floor and finishes.

Several areas of the facility have dated and sometimes makeshift interiors. These include the back stairwell, the horizontal bead board walls in the side office and the closet off the meeting hall that used to be an exterior wall. These areas will require improvements that go beyond paint and floor covering but offer opportunities to change use or enlist underutilized space. Changing one use may have an effect on the other parts of the building and lead to "scope creep" or project expansion. For instance, for an elevator to go in the side office a new area needs to be prepared for the office.

The upcoming improvements, over about 5 years, should include major repairs to the play room, proper finishes in the back stairwell, and improvements to the lobby and upgrades to the meeting hall. After that I suggest an annual maintenance allowance for
